(10) **Patent No.:** **US 9,303,515 B2**
(45) **Date of Patent:** **Apr. 5, 2016**

(54) **TURBOMACHINE DIAPHRAGM AND
METHOD OF REPAIRING A
TURBOMACHINE DIAPHRAGM**

(73) Assignee: **GENERAL ELECTRIC COMPANY**,
Schenectady, NY (US)

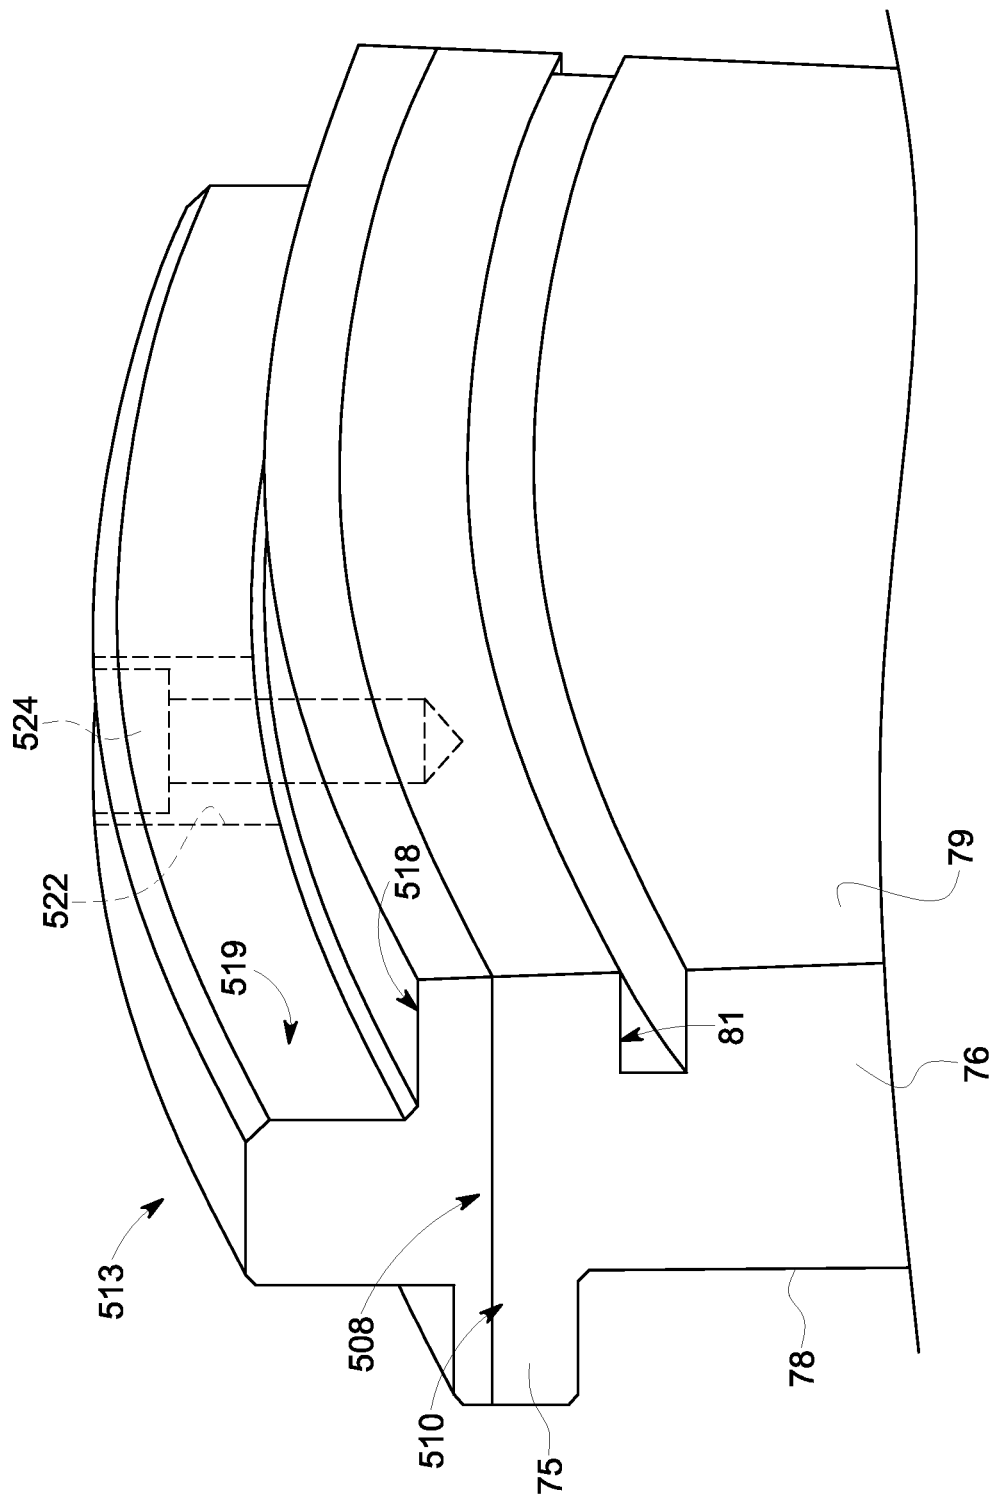
FIG. 17 is a partial plan view of a repair coupon mounted to a diaphragm rail member in accordance with yet still another aspect of the exemplary embodiment.

FIG. 17, wherein like reference numbers represent corresponding parts in the respective views, illustrates a machined surface 508 in accordance with yet still another aspect of the exemplary embodiment formed in second end section 75. Machined surface 508 defines a coupon receiving element 510 having a substantially planar surface (not separately labeled) provided with one or more threaded openings (also not separately labeled). That is, after forming machined surface 508, the original coupon is nearly completely removed from second end section 75. A repair coupon 513 is mounted to coupon receiving element 510. Repair coupon 513 includes a base section 518 and a seal section 519. Seal section 519 is mounted centrally along base section 518 to form a generally T-shaped cross-section. Repair coupon 513 includes one or more central passages 522 that are configured to align with the threaded openings formed in machined surface 508. Central passages 522 receive mechanical fasteners 524 that join repair coupon 513 to second end section 75. Of course it should be understood that repair coupon 513 could also be secured to second end section 75 through a metallurgical bond.
